Northern Air Flow

Pharmacy Cleanroom Testing and Sampling Report

Test Date: November 11, 2020
Data Report # 111120

Prepared for:
The Compounder Pharmacy
340 Marshall Avenue, Unit 100
Aurora, IL 60506

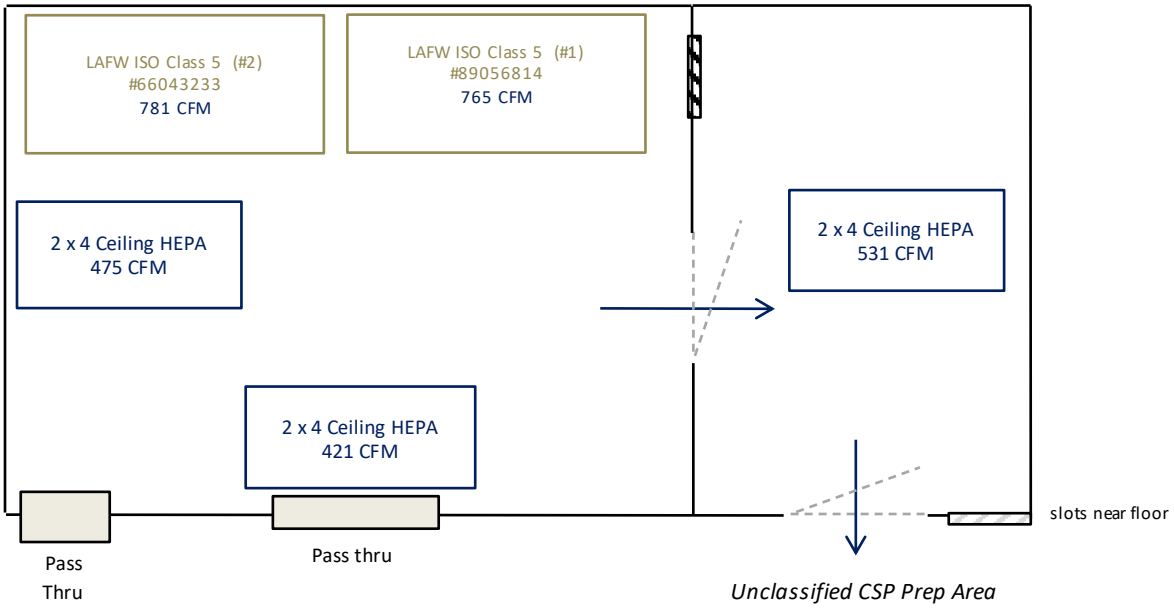
AIR CHANGES PER HOUR

Ceiling HEPA supply air: (475 + 421) x 60/ 652 = 82 ACPH.

LAFW recirculated HEPA filtered air: 1546 x 60/652 = 142 ACPH

Pass, 82 ACPH from ceiling HEPA filter.
142 ACPH from the PECs
224 ACPH combined.

Ceiling HEPA supply air: 531 x 60/323 = 99 ACPH

Pass, 99 ACPH

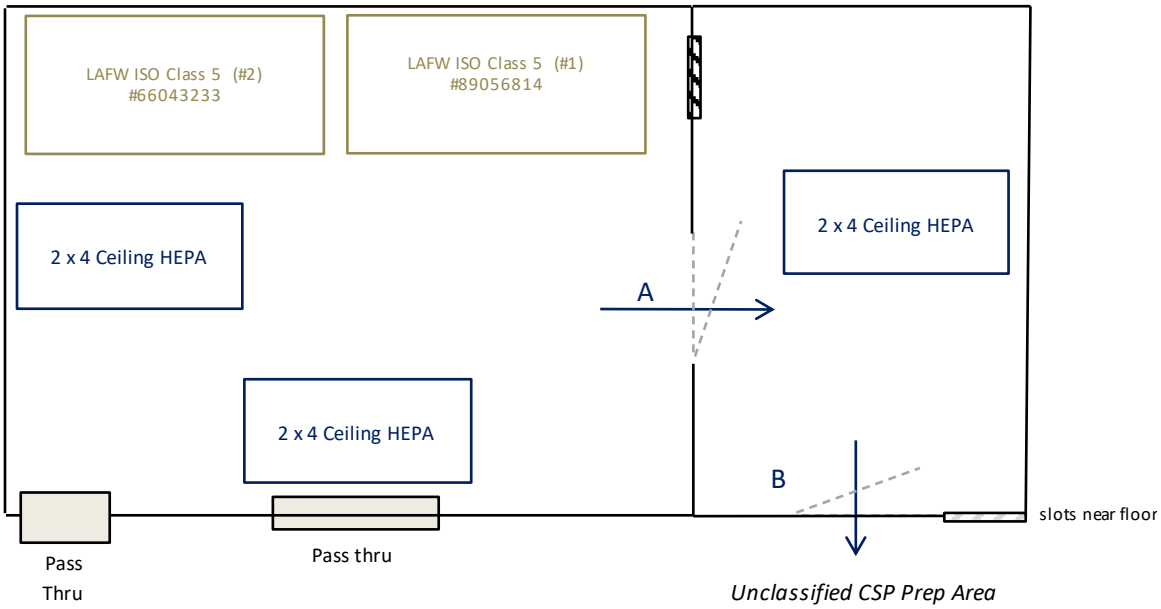
PRESSURE DIFFERENTIAL

Pass, +0.083" W.C. measured

Pass, +0.090" W.C. measured

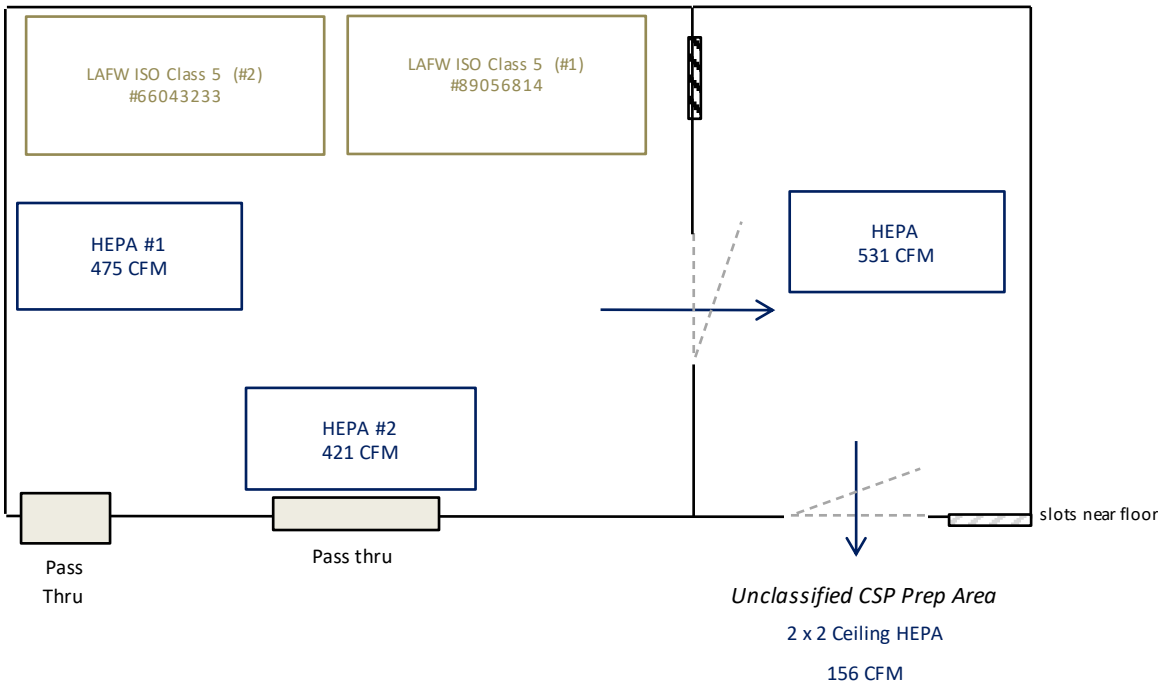
CEILING HEPA FILTER LEAK TEST

Compounding Buffer Room	**Results:**
Filter 1: 475 cfm. 14 μg/L of aerosol was introduced upstream of the filter. The HEPA filter was scanned without any significant aerosol detection, < 0.002%.	Pass
Filter 2: 421 cfm. 16 μg/L of aerosol was introduced upstream of the filter. The HEPA filter was scanned without any significant aerosol detection, < 0.001%.	Pass
Ante-Area	
Filter: 531 cfm. 13 μg/L of aerosol was introduced upstream of the filter. The HEPA filter was scanned without any significant aerosol detection, < 0.003%.	Pass
CSP Prep Area	
Filter: 156 cfm. 43 μg/L of aerosol was introduced upstream of the filter. The HEPA filter was scanned without any significant aerosol detection, < 0.004%.	Pass

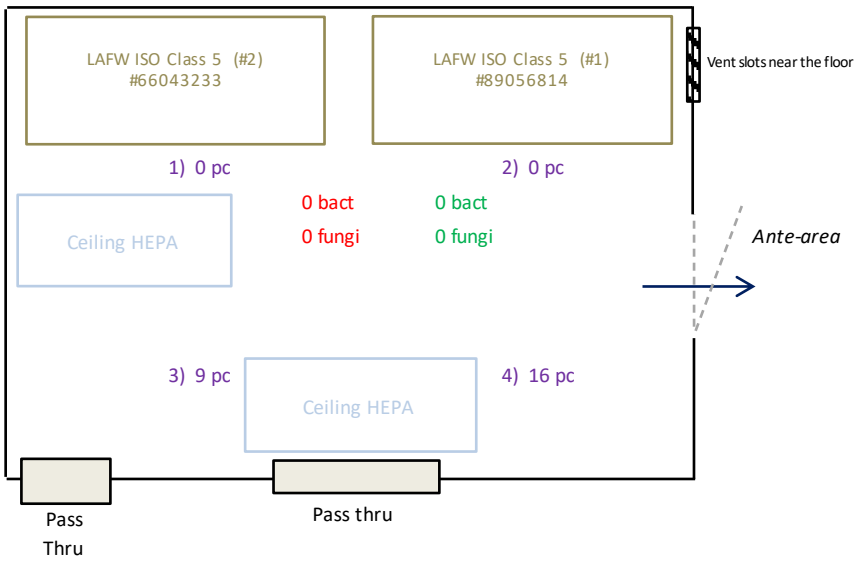
STERILE COMP0UNDING BUFFER ROOM

USP 797 acceptance criteria for an ISO Class 7 buffer area:	*Results*
Nonviable particle counts, (pc) < 10,000 particles .5 microns and larger per cubic foot. Results and locations shown on the map.	Pass
Viable air samples, ≤ 10 cfu: One cubic meter of air sampled in the center of the room.	Pass, < 1 cfu bacteria, < 1 cfu fungi
Viable surface samples, ≤ 5 cfu: Two surface samples on top of cart.	Pass, < 1 cfu bacteria, < 1 cfu fungi

Per USP 797, 2019: The cleanroom suite should be maintained at a temperature of 68 °F or cooler and a relative humidity below 60% to minimize the risk for microbial proliferation and provide comfortable conditions for compounding personnel attired in the required garb.	64 ° F, Measured 42% Relative Humidity

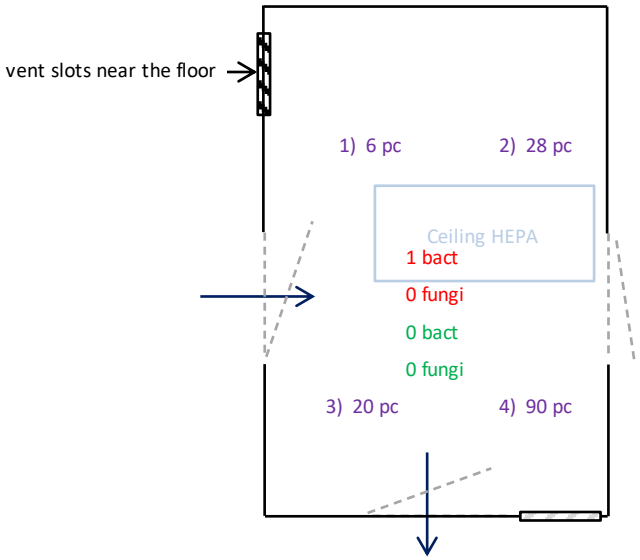
ANTE-AREA
ISO Class 8 Area, 323 cubic feet

USP<797> acceptance criteria for an ISO Class 8 ante- area:	Results
Nonviable particle counts, (pc) < 100,000 particles .5 microns and larger per cubic foot. Results and location shown on the map.	Pass
Viable air samples, ≤ 10 cfu: One cubic meter of air sampled in the center of the room.	Pass, 1 cfu bacteria, < 1 cfu fungi
Viable surface samples, ≤ 5 cfu: Two surface samples on top of the counter.	Pass, < 1 cfu bacteria, < 1 cfu fungi
Per USP 797, 2019: The cleanroom suite should be maintained at a temperature of 68 °F or cooler and a relative humidity below 60% to minimize the risk for microbial proliferation and provide comfortable conditions for compounding personnel attired in the required garb.	65 °F, Measured 41% Relative Humidity
